# Technical Appendix 10.3: Peat Slide Risk Assessment

# Carnuck Wind Farm

## Peat Slide Risk Assessment

24 March 2022

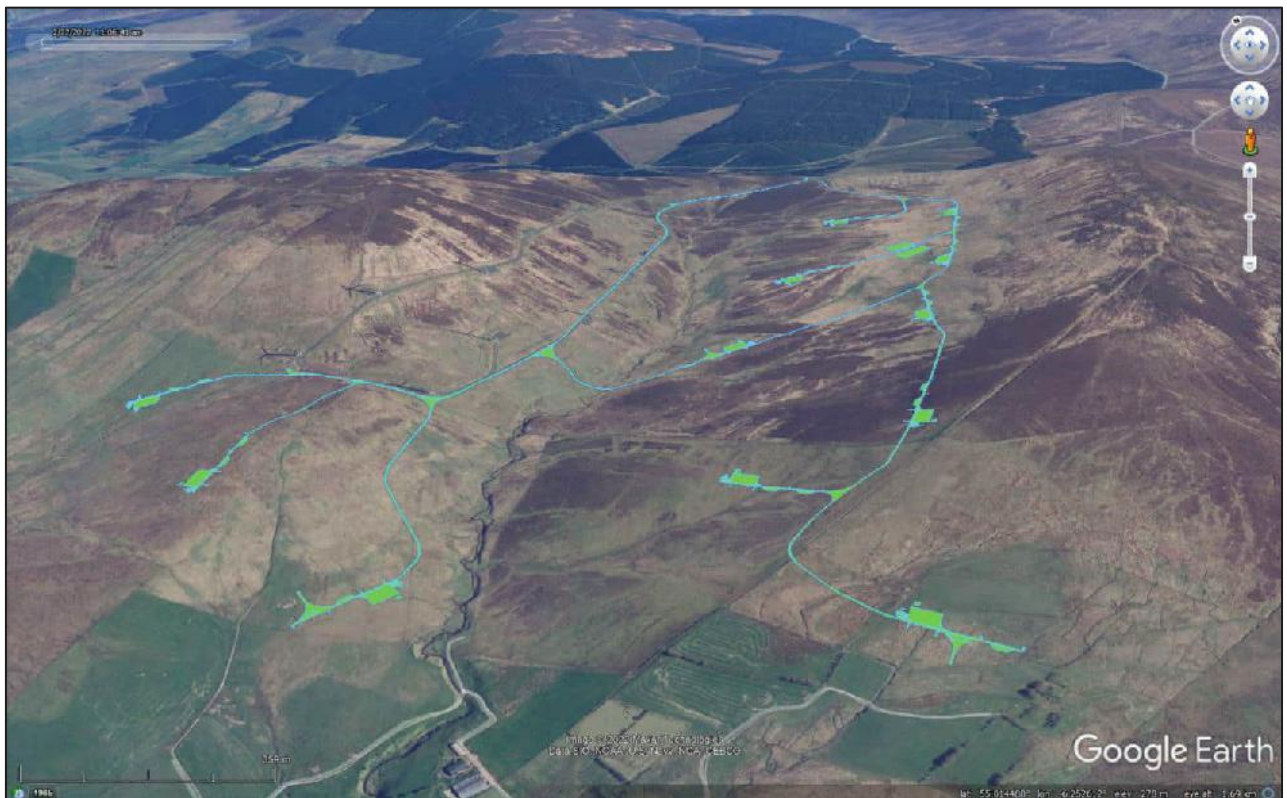
Figure 2.1: Aerial view northeast across the proposed development

Site photos taken during the peat probing surveys are included within Appendix B to provide an overview of the general ground conditions and topography encountered.

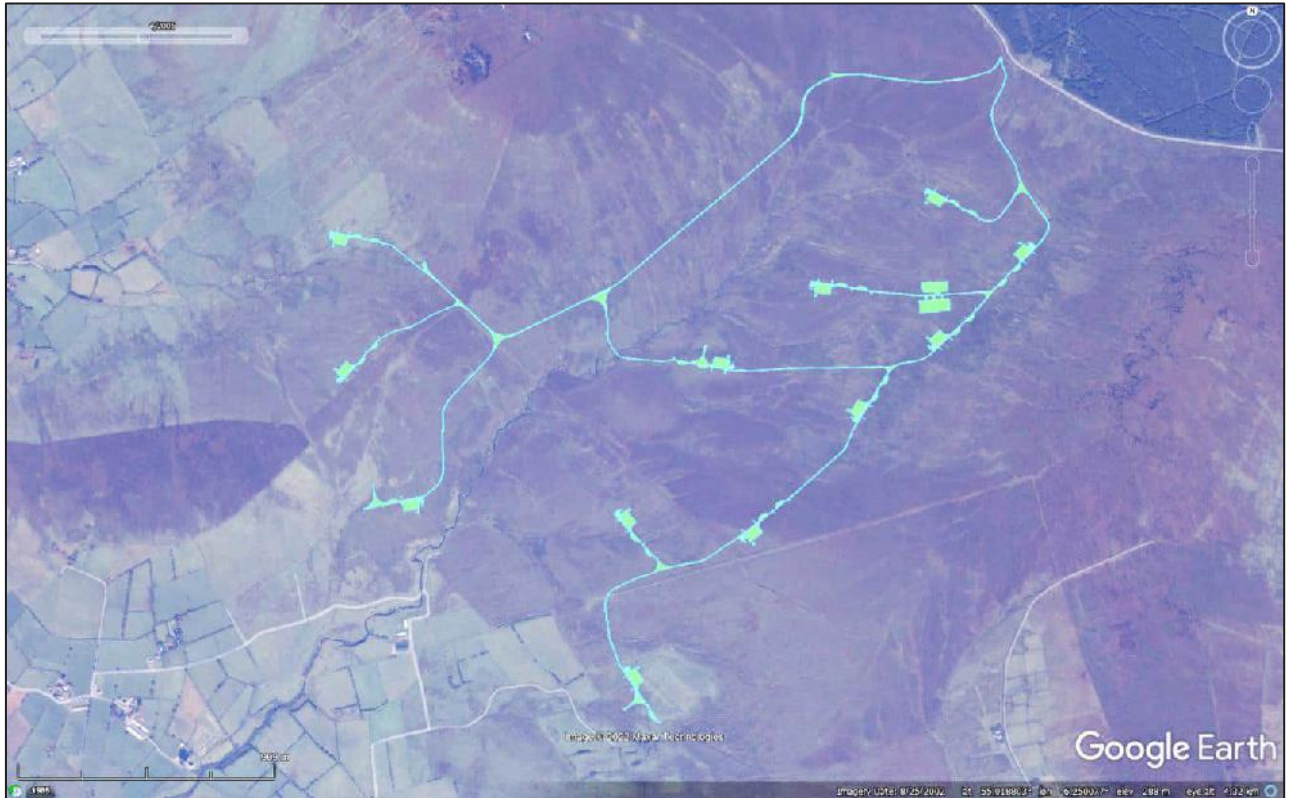
Figure 2.3: Aerial Photograph 2005

The following series of images provide an overview of the terrain and the existing wind farm development over the last decade for the proposed development. These images identify a moderate scale peat slide on the slopes of Skerry Hill that was also identified on the site walkover, the slide is known to have occurred between 2002 and 2010

An existing peat slide identified is ~360m upslope from the proposed access track at turbine T08. The feature measures approximately 3,000m<sup>2</sup> in area. The instability occurred in an area of peat hags where a failure plane is likely to have developed along the base of the peat. The trigger is postulated to have been long term erosion and infiltration of water to the base of the peat mass. The morphology of the slide has been controlled by the pre-existing peat hag geometry and the slide appearing to have taken the form of an initial slide evolving into a debris flow. Debris has been entrained and run-out for approximately 250m down-slope. The debris fan (now obscured by vegetation) has been measured from aerial photography to measure approximately 4,500m<sup>2</sup> in area.

The review of contemporary aerial photograph images for the past two decades indicates that a moderate scale peat slide occurred on the sloped of Skerry Hill pre-2010. No windfarm infrastructure is positioned within the vicinity of this peat movement. The run-out distance of the peat slide was such that it has not reached the areas of proposed infrastructure. This natural slope instability on the side of Skerry Hill has also been highlighted within Figure A.1, this is not thought likely to change due to the Proposed Development. Extensive networks of peat drainage ditches and extensive peat cutting can be seen all the way back to the earliest available photography in 2002.

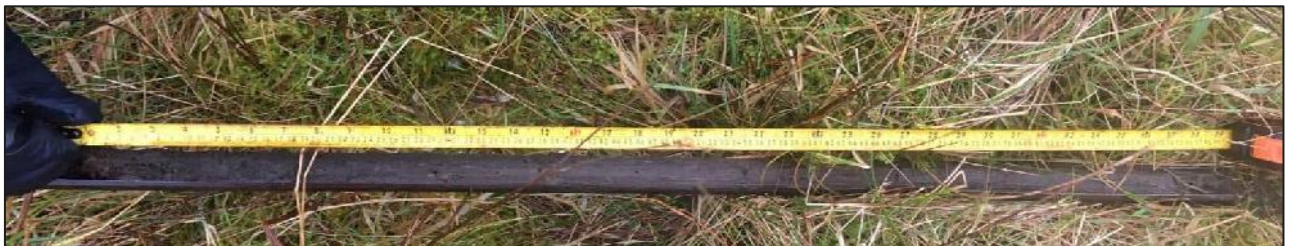
Figure 2.5: Peat Core at Turbine T10

The peat encountered across the development is typically soft to firm dark brown, pseudo-fibrous, plastic, PEAT with little amorphous material due to the low depths encountered. Von Post classes are predominantly H4 - H5. Two photos of typical peat cores taken across the site are presented in Figure 2.5 and Figure 2.6.

15No. peat core samples were submitted to the laboratory for Carbon content (% by weight) and dry soil bulk density testing. The average site wide total carbon content was **31%** and the average dry bulk density was **0.27 Mg/m<sup>3</sup>**.

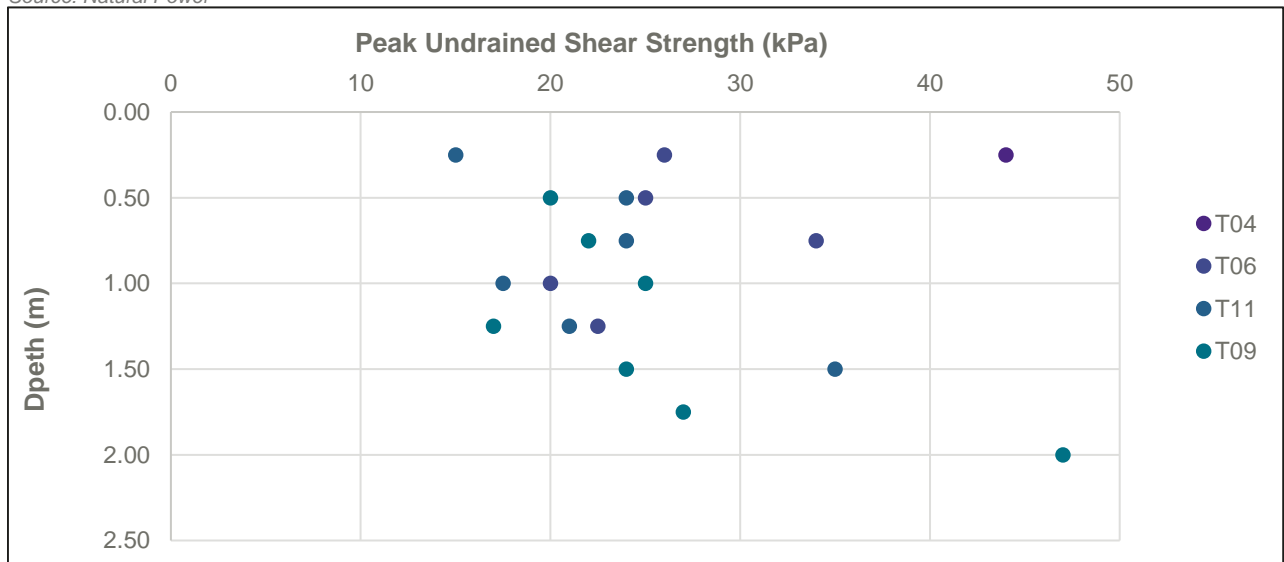
Figure 2.8: Undrained Shear Strength of Peat Soils

Figure 2.8 depicts the peak un-drained shear strength data with depth:

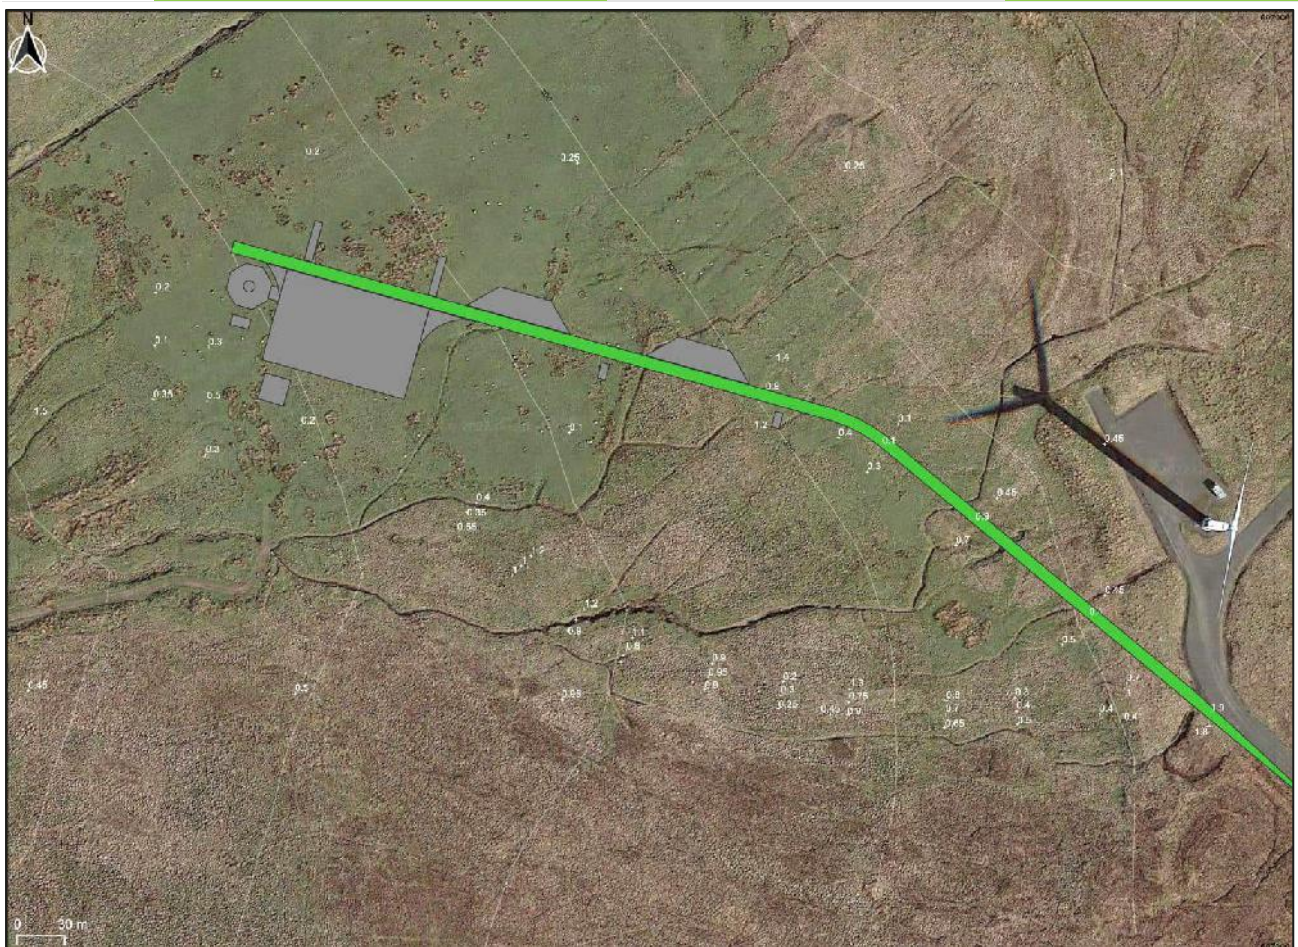
T01 Location – Google Aerial Imagery – 1:5000 Scale

WTG ID	Adverse Consequence		Contributory Factors (Probability/Exposure)	Risk Ranking
	Development Infrastructure	Environmental		
T01	1	1	Peat Depth (Mean = 0.30m)	1
			Slope Angle (6°)	3
			FoS (Min = $Cu_{min}$ > site mean)	1
			Peat cracking / Infiltration	1
			Groundwater Flow	1
			Hydrology	1
			Previous Instability	1
			Land Management	1
				<b>Risk = 1 x 3 = 3 (Negligible – Not Peat)</b>

Minor ephemeral streams can be seen around the turbine base however these are not believed to have any potential for off-site movement of peat, hence have not been considered when evaluating the environmental hazard.

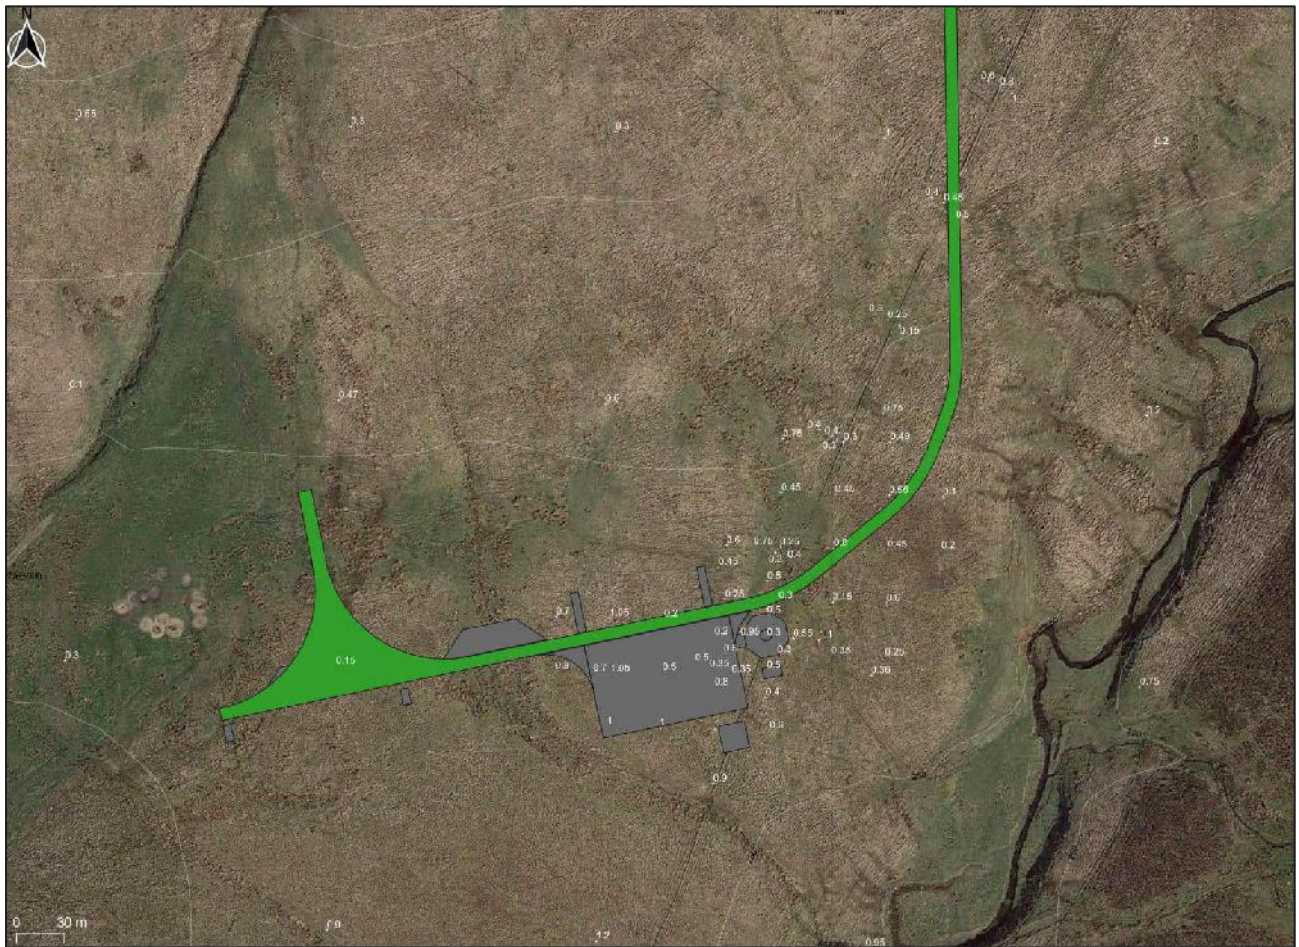
T03 Location – Google Aerial Imagery – 1:5000 Scale

WTG ID	Adverse Consequence		Contributory Factors (Probability/Exposure)	Risk Ranking
	Development Infrastructure	Environmental		
T03	1	3	Peat Depth (Mean = 0.50m)	1
			Slope Angle (5°)	3
			FoS (Min = $Cu_{min}$ > site mean)	1
			Peat cracking / Infiltration	1
			Groundwater Flow	1
			Hydrology	1
			Previous Instability	1
			Land Management	1
				<b>Risk = 3 x 3 = 9 (Low)</b>

Elevated Environmental factor due to the close proximity to main on-site water course.

Following further intrusive site investigation post-consent, the risk ranking should be re-evaluated. The risk should remain negligible given the absence of continuous deep peat at this location.

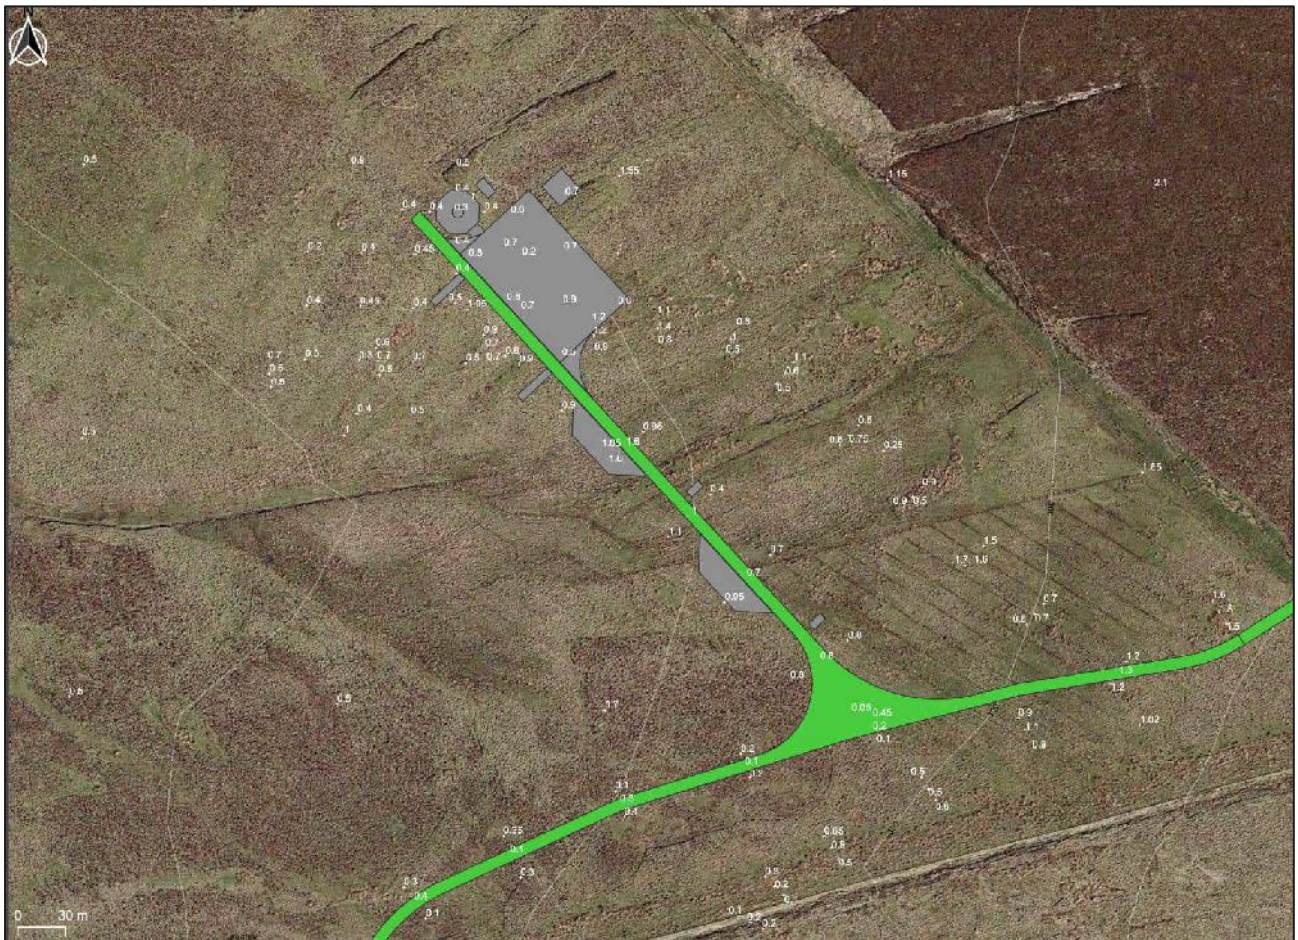
T04 Location – Google Aerial Imagery – 1:5000 Scale

WTG ID	Adverse Consequence		Contributory Factors (Probability/Exposure)	Risk Ranking
	Development Infrastructure	Environmental		
T04	1	1	Peat Depth (Mean = 0.40m)	1
			Slope Angle (5.5°)	3
			FoS (Min = $Cu_{min}$ > site mean)	1
			Peat cracking / Infiltration	1
			Groundwater Flow	1
			Hydrology	1
			Previous Instability	1
			Land Management	2
<b>Risk = 1 x (3+2) = 5 (Low)</b>

Adjacent watercourse is minor and sufficiently proximal from the main watercourse on site. This combined with the shallow peat depth which has resulted in low risk.

Drainage measures should be implemented to re-route any up-slope water supplies and ensure outflows from the infrastructure is not concentrated onto the downslope peat deposits.

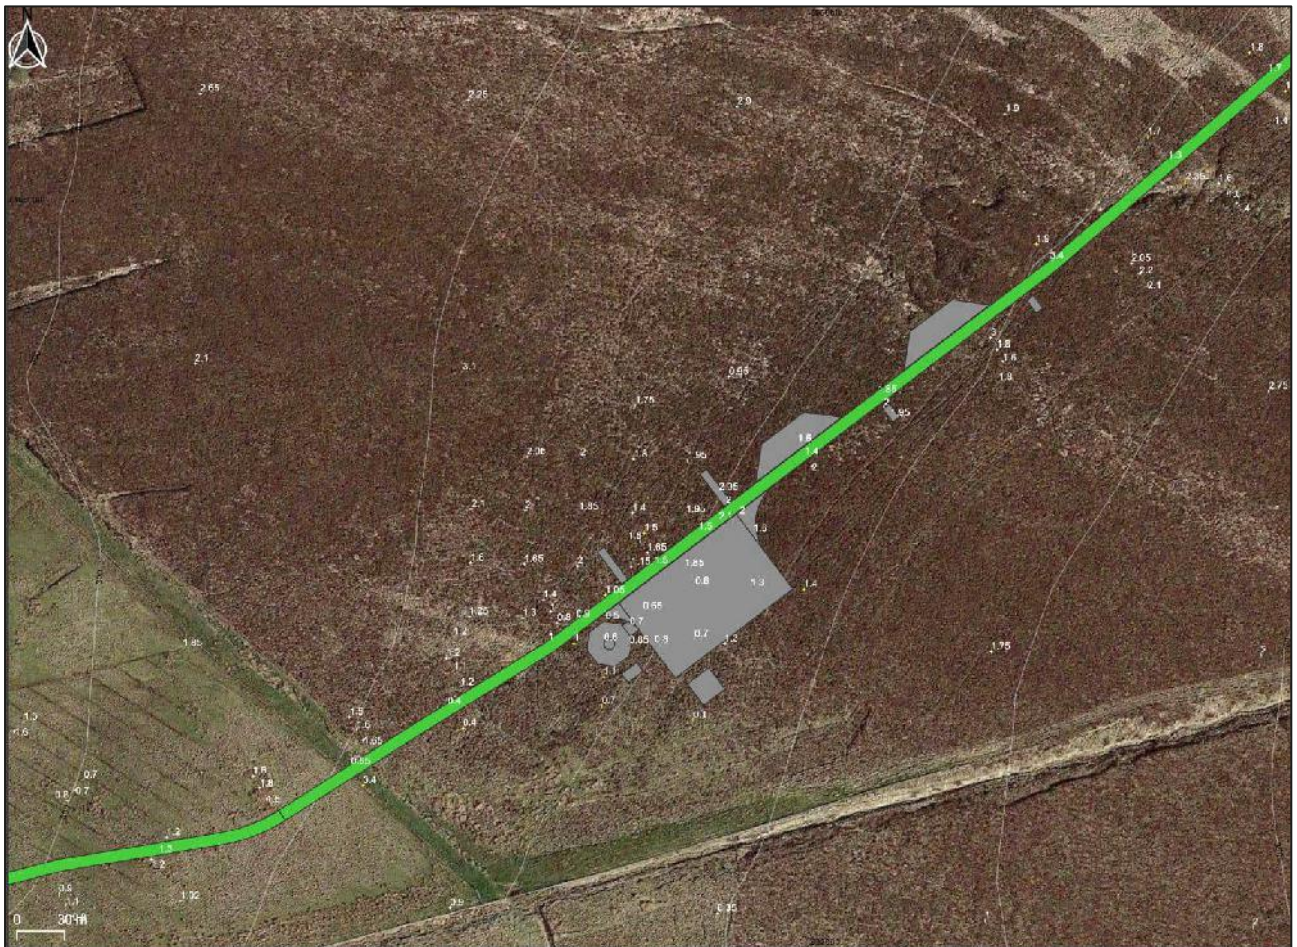
T06 Location – Google Aerial Imagery – 1:2,500 Scale

WTG ID	Adverse Consequence		Contributory Factors (Probability/Exposure)	Risk Ranking
	Development Infrastructure	Environmental		
T06	1	1	Peat Depth (Mean = 0.80m)	3
			Slope Angle (6°)	3
			FoS (Min = $C_{u_{min}}$ > site mean)	1
			Peat cracking / Infiltration	1
			Groundwater Flow	1
			Hydrology	1
			Previous Instability	1
			Land Management	1
<b>Risk = 1 x (3+3) = 6 (Low)</b>

The slope angle and peat depth are contributory factors at this site. No temporary storage of peat on the slopes around the turbine base.

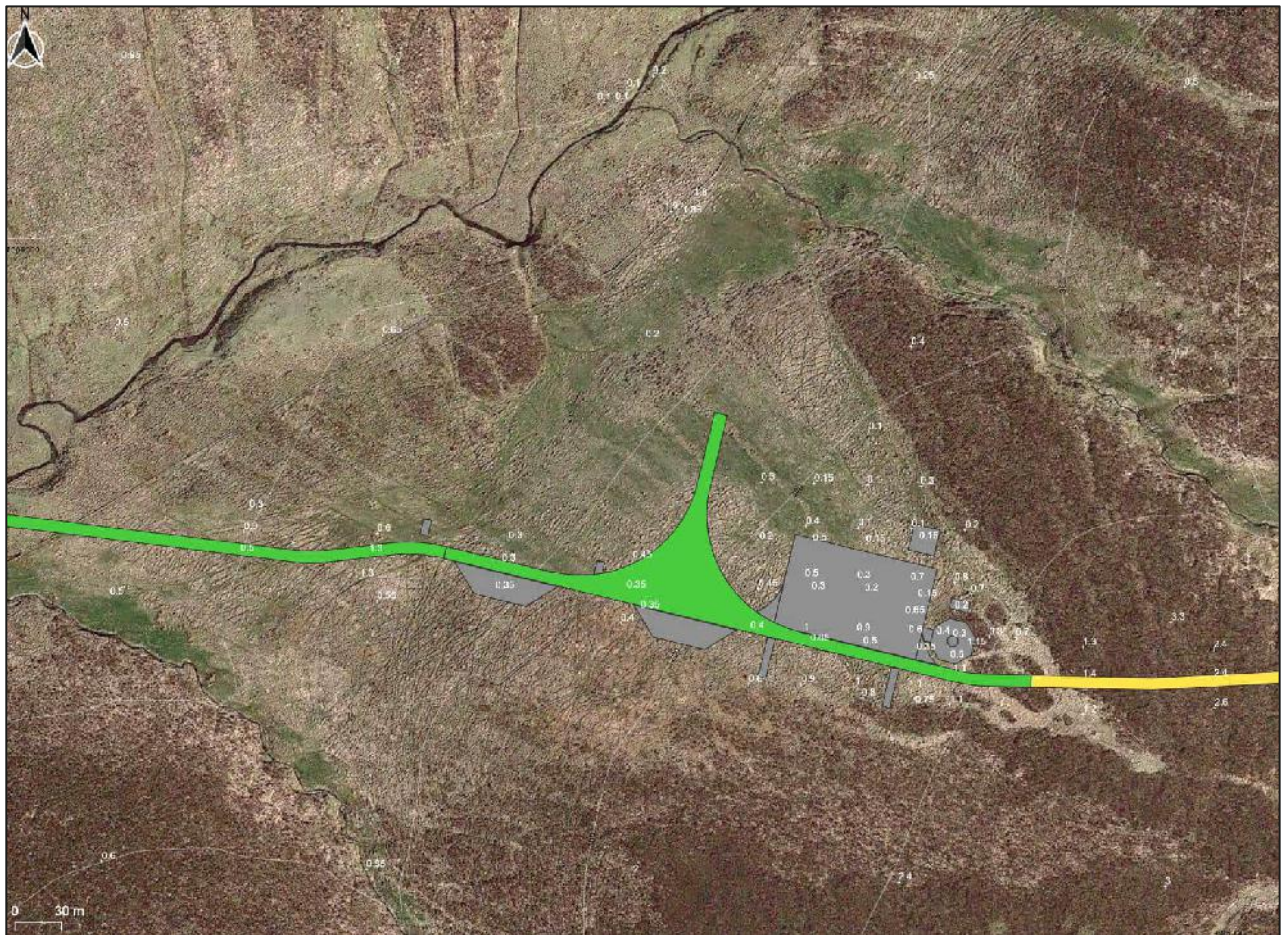
T07 Location – Google Aerial Imagery – 1:5000 Scale

WTG ID	Adverse Consequence		Contributory Factors (Probability/Exposure)	Risk Ranking
	Development Infrastructure	Environmental		
T07	1	2	Peat Depth (Mean = 0.40m)	1
			Slope Angle (3°)	1
			FoS (Min = $C_{u_{min}}$ > site mean)	1
			Peat cracking / Infiltration	1
			Groundwater Flow	1
			Hydrology	1
			Previous Instability	1
			Land Management	1
				<b>Risk = 2 x (1) = 2 (Negligible)</b>

No temporary storage of any peat on the steeper slopes around the turbine base. Drainage measures should not direct or concentrate down slope flow into the peat deposits.

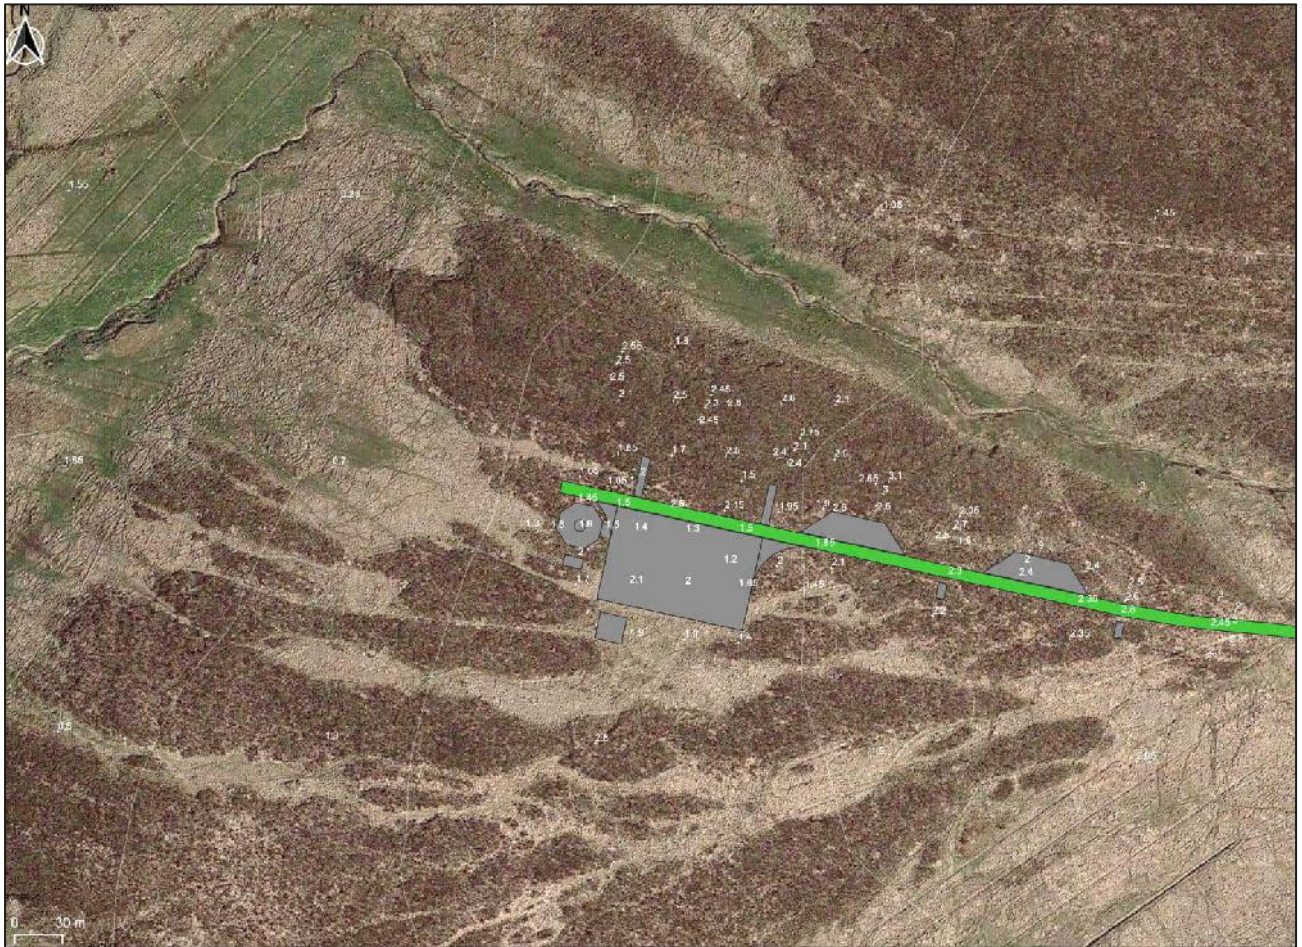
T09 Location – Google Aerial Imagery – 1:2,500 Scale

WTG ID	Adverse Consequence		Contributory Factors (Probability/Exposure)	Risk Ranking
	Development Infrastructure	Environmental		
T09	1	2	Peat Depth (Mean = 1.60m)	5
			Slope Angle (3°)	1
			FoS (Min = $Cu_{min}$ > site mean)	1
			Peat cracking / Infiltration	1
			Groundwater Flow	1
			Hydrology	1
			Previous Instability	1
			Land Management	1
<b>Risk = 2 x (5) = 10 (Low)</b>

Elevated Environmental factor due to the proximity to main water course.

Following further intrusive site investigation post-consent, the risk ranking should be re-evaluated. A higher confidence in the geometry of the basal peat interface and understanding of the geotechnical properties of the underlying superficial deposits will allow for more confidence in the risk ranking. No temporary storage of peat at this location.

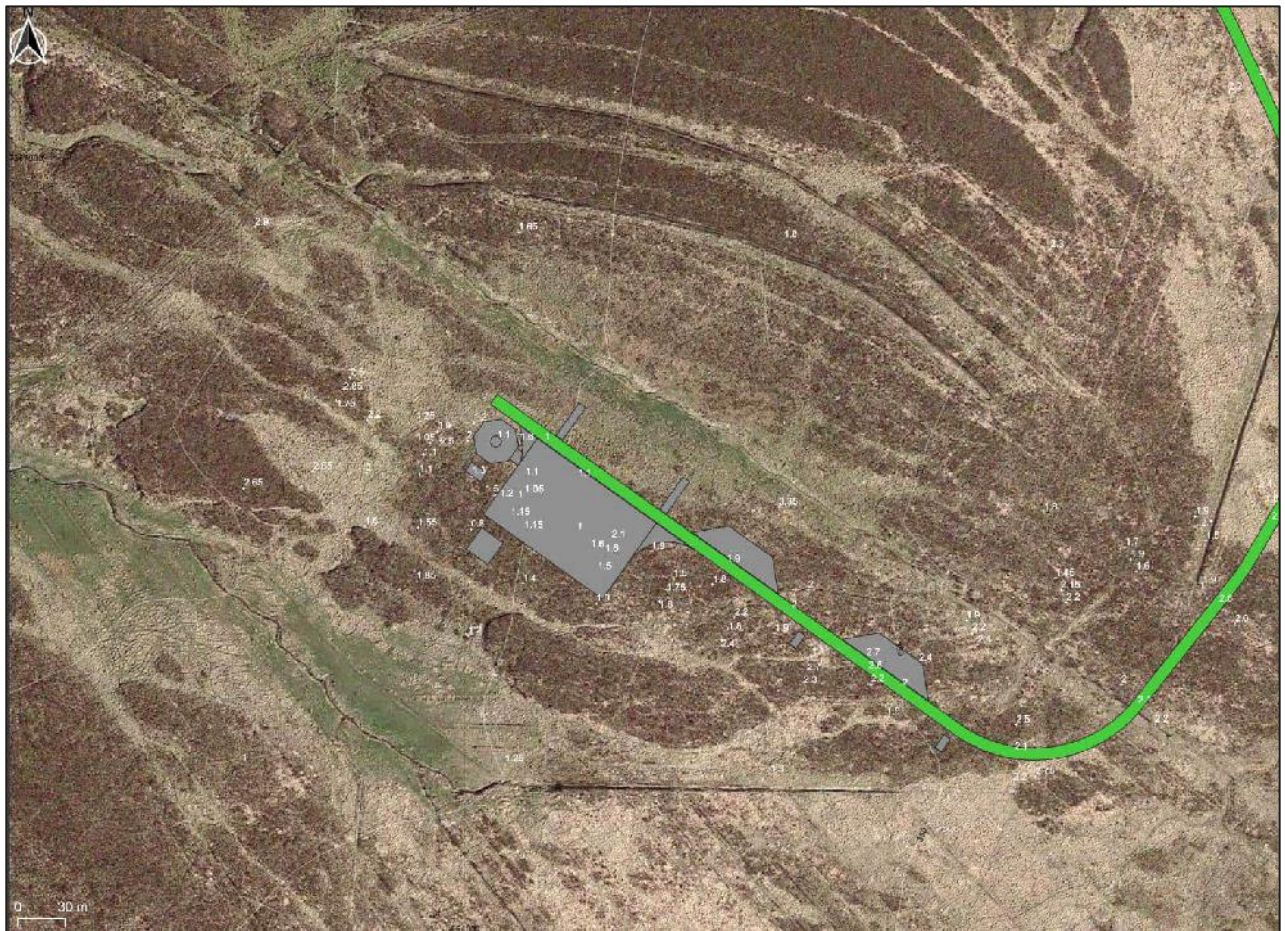
T11 Location – Google Aerial Imagery – 1:2,500 Scale

WTG ID	Adverse Consequence		Contributory Factors (Probability/Exposure)	Risk Ranking
	Development Infrastructure	Environmental		
T11	1	1	Peat Depth (Mean = 1.60m)	5
			Slope Angle (5°)	3
			FoS (Min = $Cu_{min}$ > site mean)	1
			Peat cracking / Infiltration	1
			Groundwater Flow	1
			Hydrology	1
			Previous Instability	1
			Land Management	1
<b>Risk = 1 x (5+3)</b>				
<b>= 8</b>				
<b>(Low)</b>

Elevated Environmental factor due to the proximity to a water course however the watercourse is minor and distant from main on-site watercourse.

Following further intrusive site investigation post-consent, the risk ranking should be re-evaluated. A higher confidence in the geometry of the basal peat interface and understanding of the geotechnical properties of the underlying superficial deposits will allow for more confidence in the risk ranking. No temporary storage of peat at this location.
